Traverse County Courthouse

BUILDING EVALUATION - SPACE NEEDS STUDY 16 JULY 2012

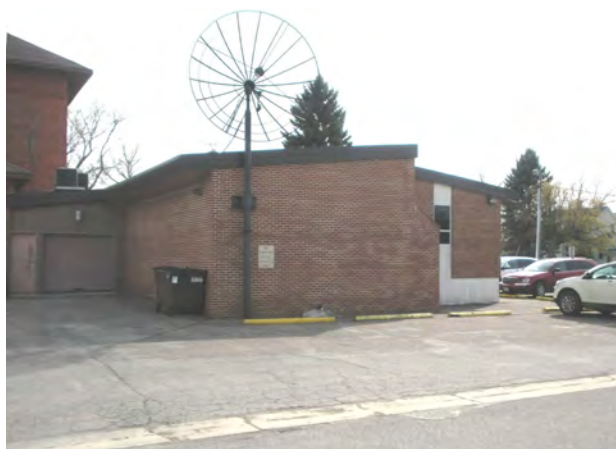
The 1974 addition was originally constructed as a Law Enforcement Center housing the County Sheriff's Department and Jail. It is a two level masonry structure with precast plank upper floor that aligns with the floor of the original courthouse building. The aluminum windows and entries are single glazed and there are no entry vestibules. The roof slope east and west and has caused water damage to the existing

View of north side of 1974 addition and garage

courthouse masonry and electrical components. The lower level, former jail, is below the existing parking lot grade and is currently empty due to water infiltration and flooding. Mold remediation has taken place, but the floor remains unusable do to water problems. The interior mainly consists of concrete block partitions and currently houses county departments.

Option 1 would involve the repair and re-grading of the parking lot and site area around the 1974 addition to better control the surface water runoff from the roof areas of the addition and the courthouse. Some roof work on the addition and the old one story jail portion of the courthouse would be required to further direct the flow of roof water by adding cutters and downspouts. Site grading improvements appear to be required to further direct water away from the foundation of the 1974 addition. All roof rainwater falls directly to the ground without any gutter or downspout controls. Carrying the water away from the building and regarding the parking lot and landscaping would assist in control of water intrusion problems reported in the basement of the 1974 addition. Using soil borings would provide for further investigation of the water table at the site.

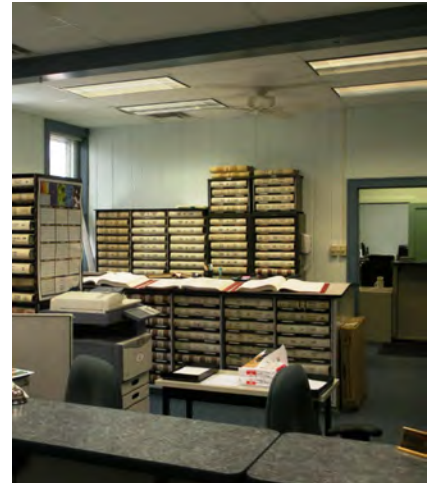
The lack organization of the storage and access to county records for all departments is evident. Without security or a fire protection system, the records stored in the open are subject to vandalism or loss.

Access for county record books is still required

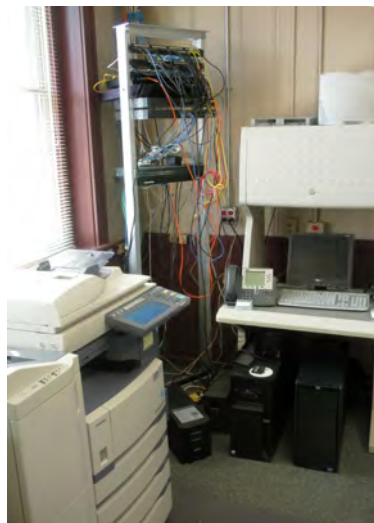
Lack organization and centralization of data and communications equipment is evident throughout the facility. There is a need for a centralized communications and data equipment room that would allow for organization of the systems and better security and environmental conditions for the equipment. Likewise better routing and access for cable management would provide for a neater work environment.

A centralized data room is needed

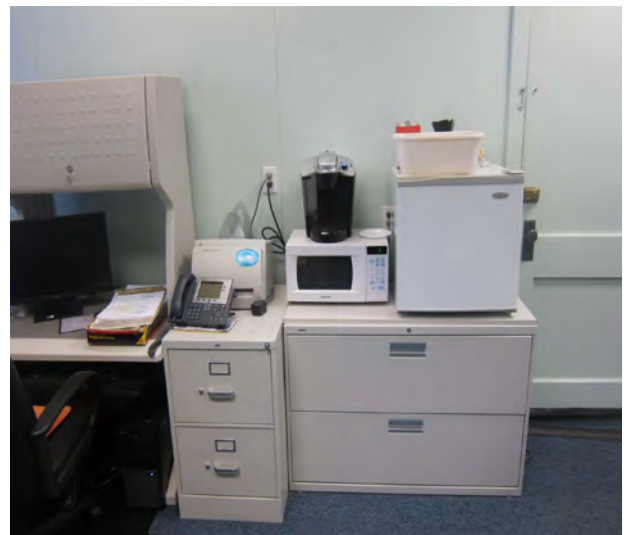
A shared break room would eliminate clutter

The need for a common employee break room separate from the office spaces is also evident from the numerous refrigerators, microwaves and coffee makers scattered throughout the office areas.

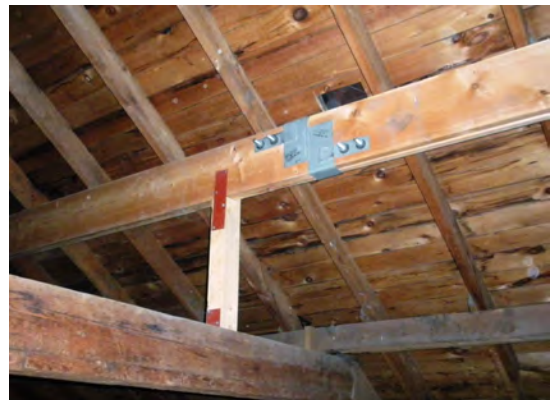
Added attic roof framing support

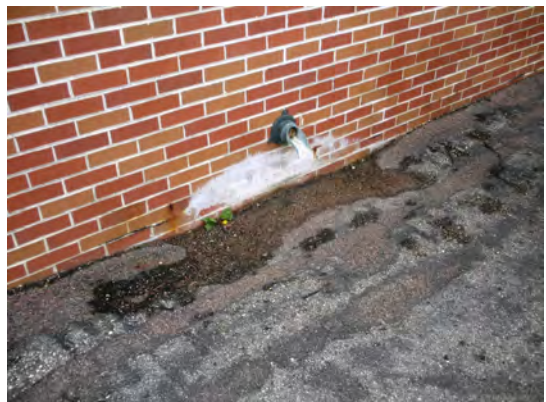
Parking lot settlement at 1974 addition resulting in water damage

Settlement of the grade around the building, especially the 1974 addition has caused damage to the stone foundation and added to the water infiltration problems at the 1974 additions lower level.

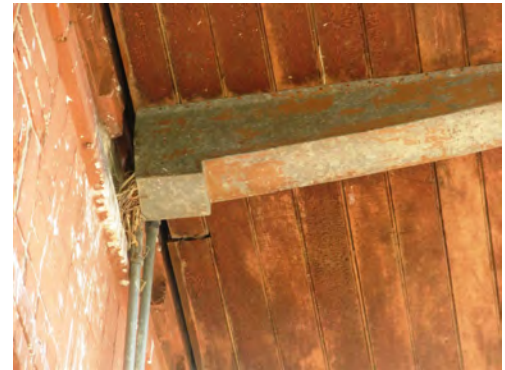
Rusted metal soffit trim and gap

The interior sheathing did not appear to show significant water staining or other signs of infiltration and no roof leaks have been reported by county staff. The main roof replacement is likely not needed at the current time. The existing painted galvanized metal trim, appears to be in poor condition with evidence of rusting and gaps between the trim and the masonry.

Roof replacement is not needed at the current time, and only normal maintenance is recommended. At a few locations the metal has separated from the building. Any deteriorated wood blocking should be repaired or replaced. The metal at these areas should be reattached to the face of the soffit so that it can perform its intended role.

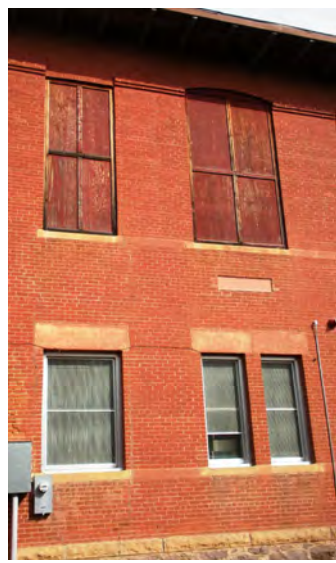
Existing window openings

The existing windows were predominantly wood, one-over-one double-hung windows with arched tops on the second floor and square transom tops on first floor. Extruded aluminum replacement sashes have replaced the original wood windows and in other areas the existing windows have been replaced with painted plywood panels or masonry infill. The aluminum replacement windows

throughout the building appear to be in average to poor condition. However, the aluminum storm and screen units are not historic in appearance and as they are single glazed; they provide little additional energy performance. Plywood window closure panels have deteriorated and require repainting or replacement.

Provide for removal of existing aluminum replacement window sash and replace with painted aluminum clad wood windows, with low E clear insulating glass and operating sash. Window interiors should match any remaining existing wood trim and finishes. Fixed aluminum clad wood transom windows should be provided in the upper sash. Exterior aluminum profile should match a typical historic brick mold. The thermal performance of window replacement option would offer a significant energy improvement over the existing windows. The boarded up existing window openings should be removed and replaced with new windows and the interiors remodeled to accommodate this change.

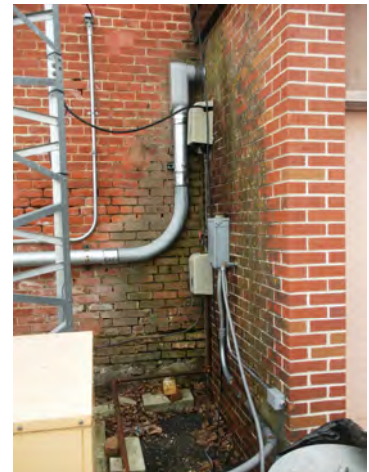
Uncontrolled roof water from the 1974 addition has damaged the masonry and electrical equipment at several locations

Damaged brick and electrical conduits

- Asset preservation-type improvements, including painting and masonry tuckpointing.
- Monitoring of the settlement cracking of the masonry and eventual repair of the 1891 foundation.
- Add rain drainage control with gutters, downspouts to control roof drainage.
- Replacement of the roof on the 1974 addition and the 1 story old jail.
- Wood board soffits should be replaced and the metal trim removed, painted and reinstalled.
- Replace the existing canopies over the south and east entries with more permanent structures.

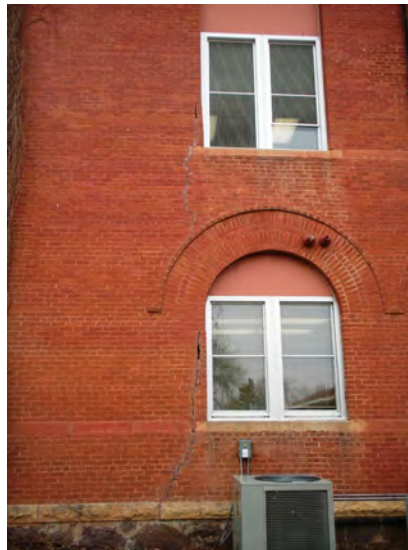
Cracking in masonry at the east elevation

was placed on concrete footings and is not showing evidence of settlement problems. The existing courthouse however continues to settle due to deterioration of the stone footings, roof runoff and groundwater issues.

There is cracking evident at a significant number of brick and stone joints on the east and west elevation of the 1891 Courthouse walls. The cracks in brick joints have been repaired previously, leading to the assumption that they are a continuing source of movement in the wall. Cracking of the brick joints at Courthouse seems to be more prevalent on the east and west portions of the walls near where the tower was removed and replaced with the 1920s addition.

Future monitoring of the movements of the wall may indicate further problems with the stone foundation. Re-pointing of the cracks in several areas of the walls and the joints along the stone water table should be part of the restoration plan to ensure proper function of the wall assembly. The re-pointing should include removal of the sealant joints and any deteriorated mortar present in the masonry joints, cleaning and preparation of the existing joint, and replacement with a mortar type which closely matches the original. Removal of the exterior face of mortar should extend deep enough to reach the original mortar. All replacement mortar and sealant must be removed. Studies of historic mass masonry wall systems, like the ones at the Traverse Courthouse, have found that this mass when heated or cooled can actually be highly efficient when left in their existing un-insulated state and will behave as was originally intended. No improvements to the insulating values of the exterior wall are recommended.

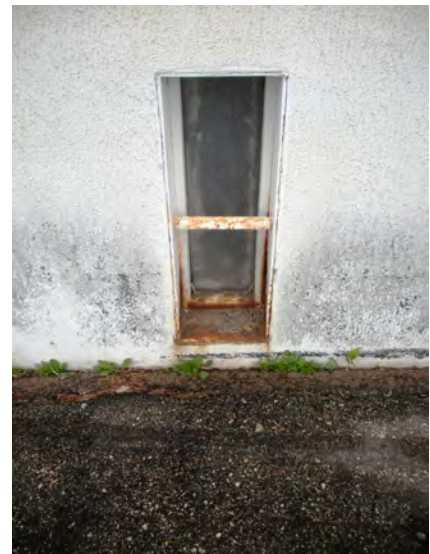
Black line on wall shows where parking grade has settled at old jail window

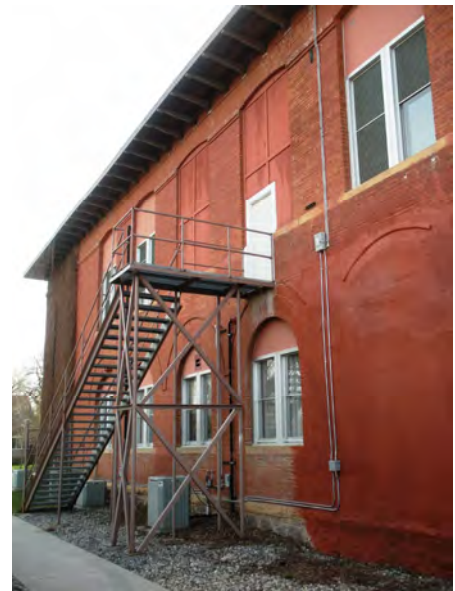
Steel fire escape

1. The existing fire escape stair should be removed and replaced with a code compliant stair as a second means of egress from the second floor.
2. Access to the second exit (fire escape) stair and other egress doors should be improved as a part of the future renovations. This includes door swinging in the direction of exit travel and fire rating improvements of the existing doors; including the hatch to the attic.
3. Stair handrails do not meet current code standards for extensions.

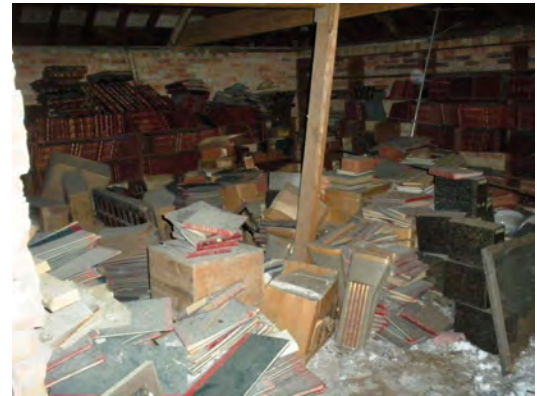
Books stored in attic space
