TRAVERSE COUNTY COURTHOUSE

MAJOR STRUCTURAL CONCERNS

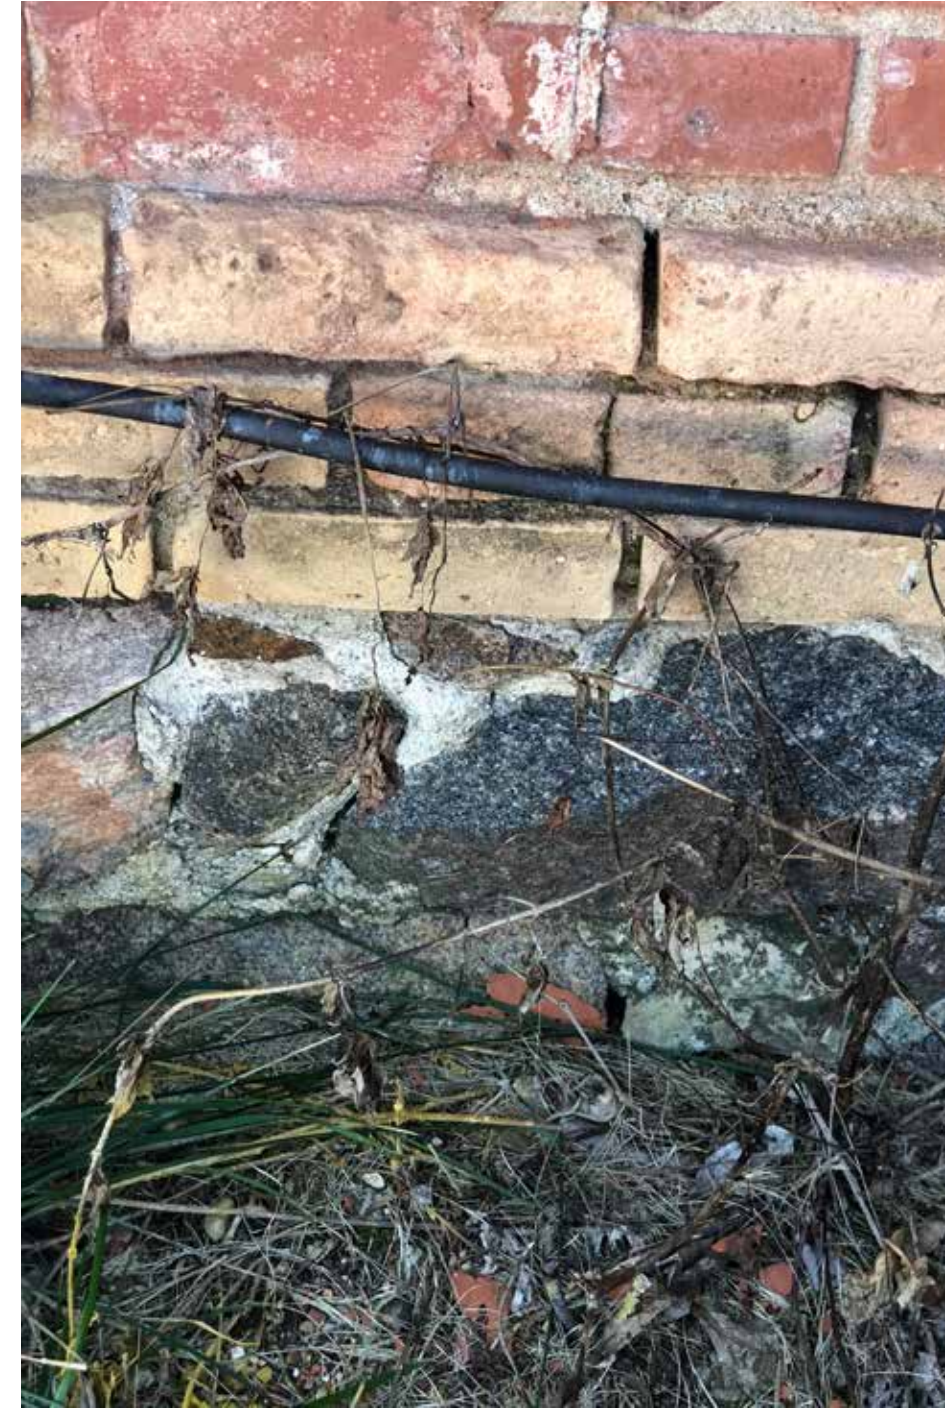
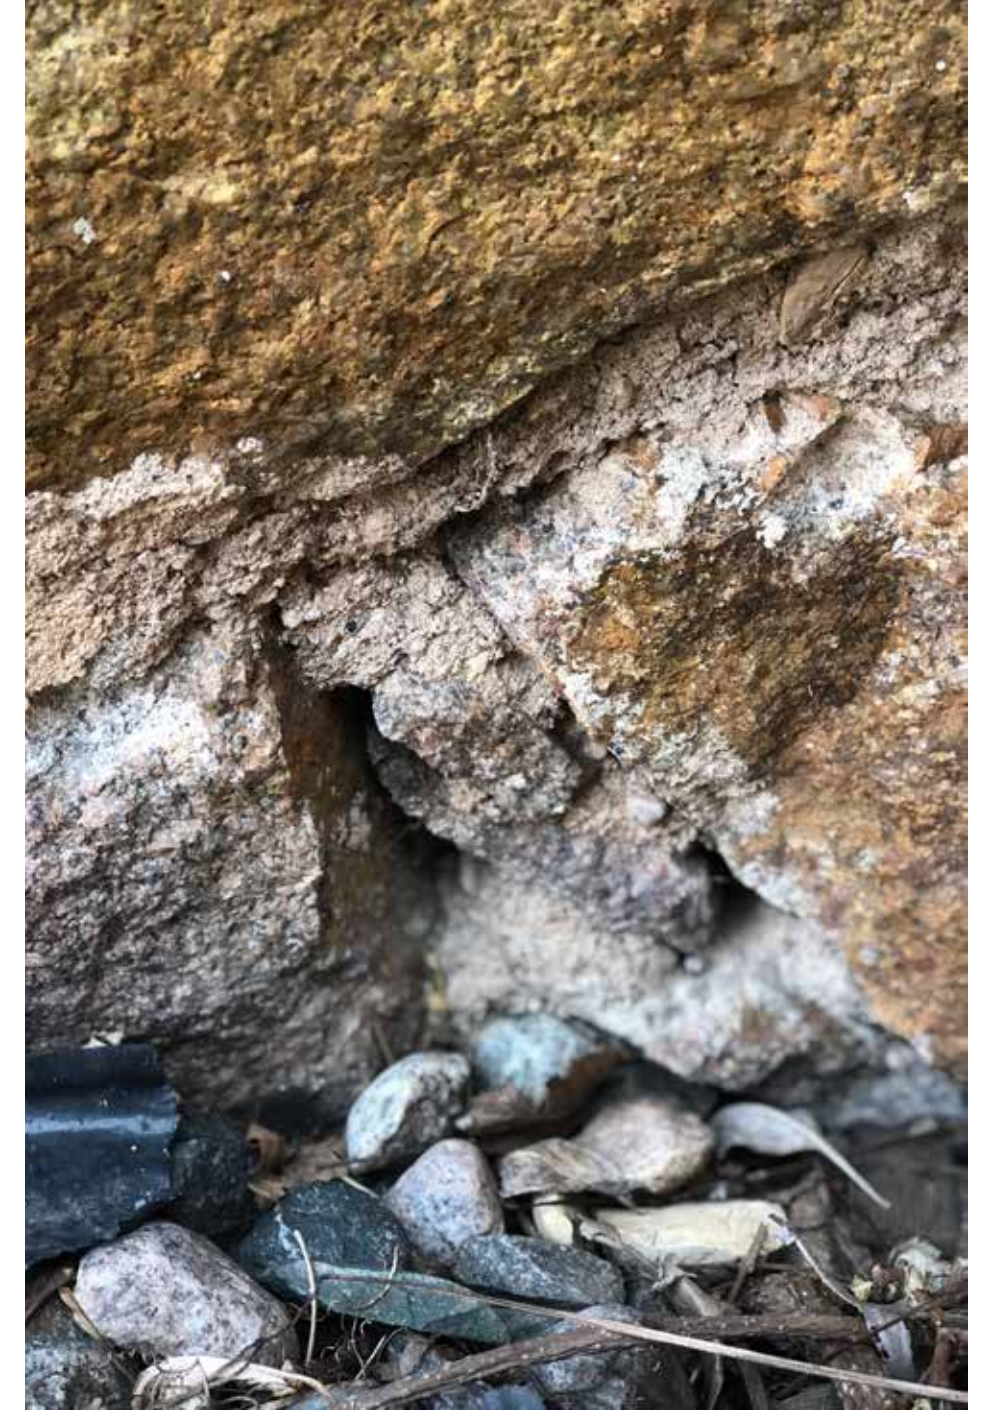
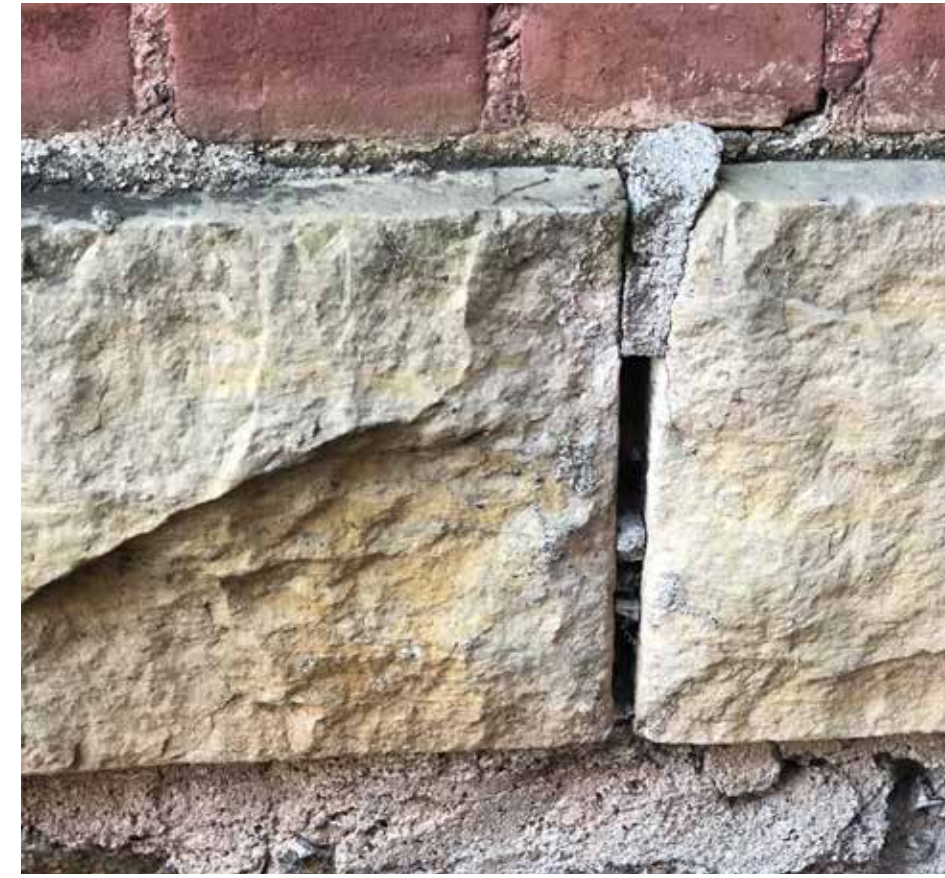
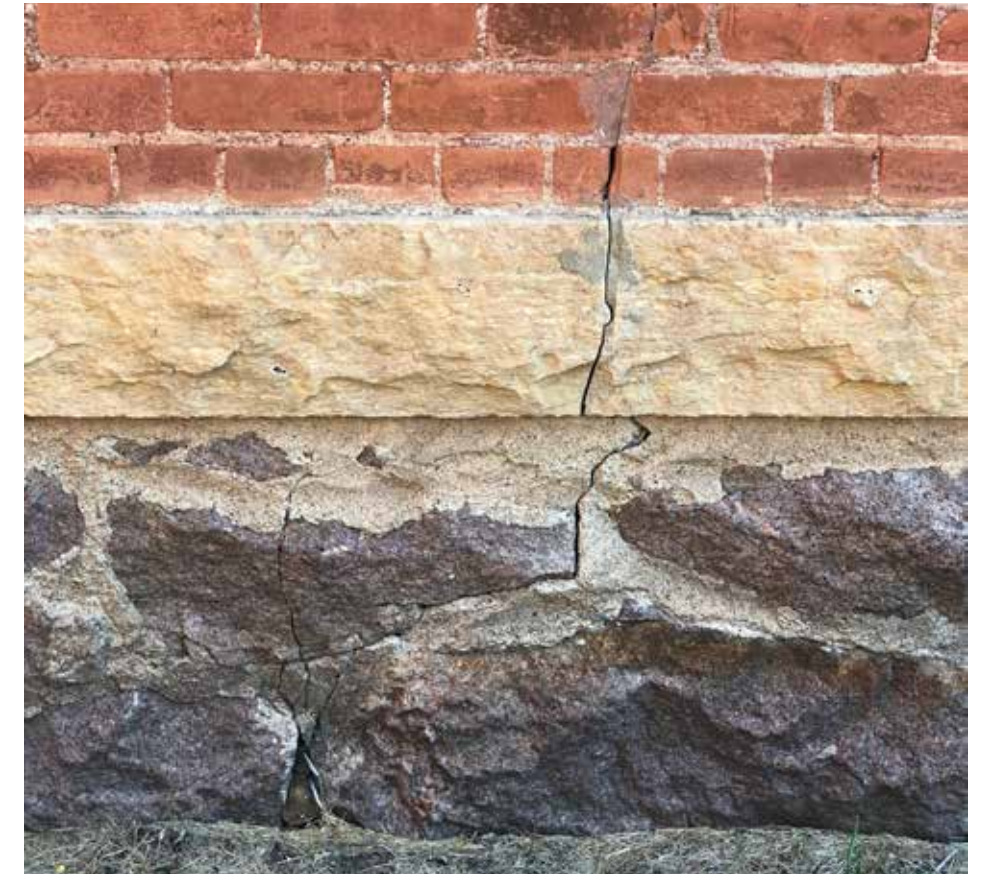
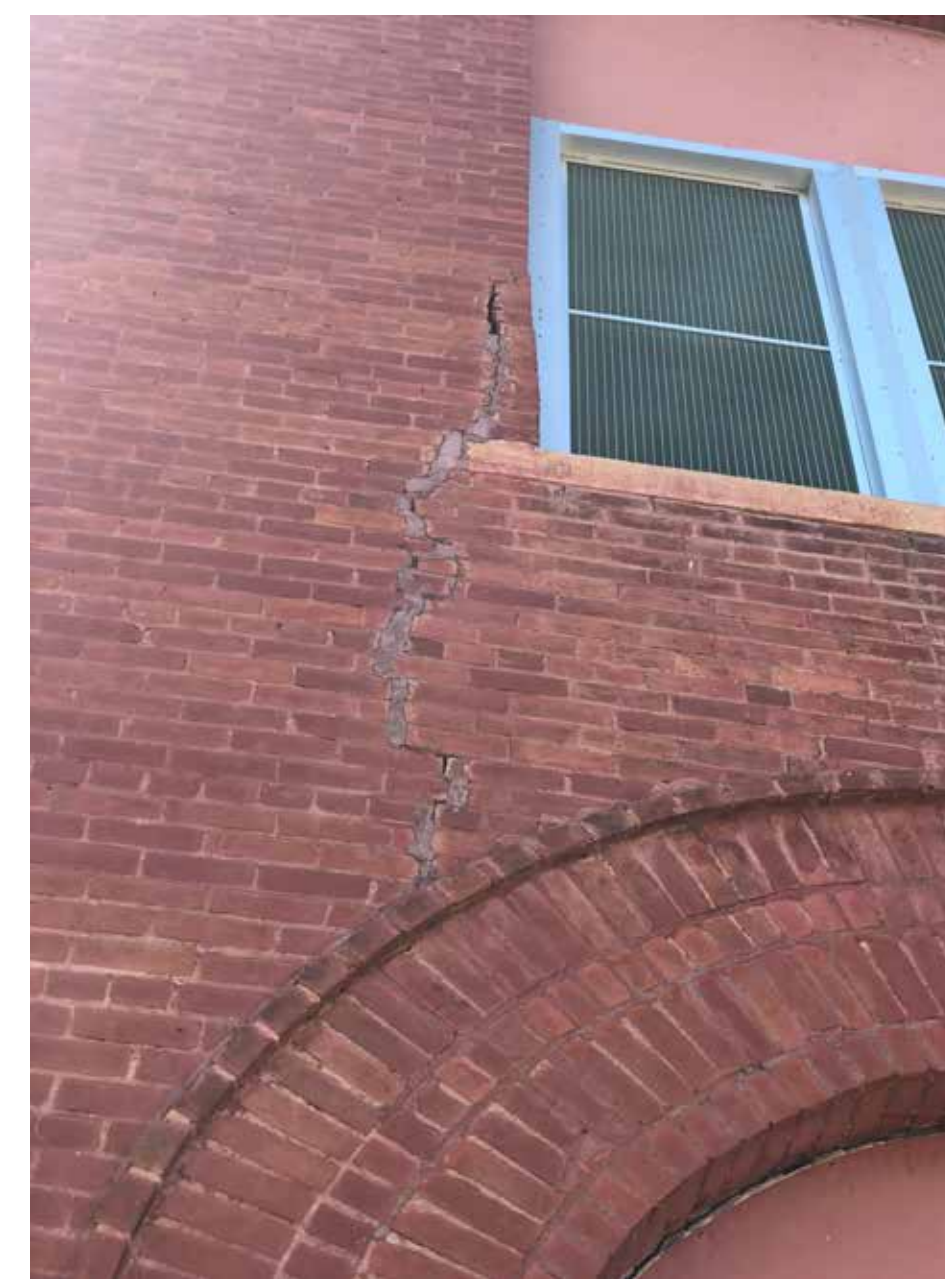
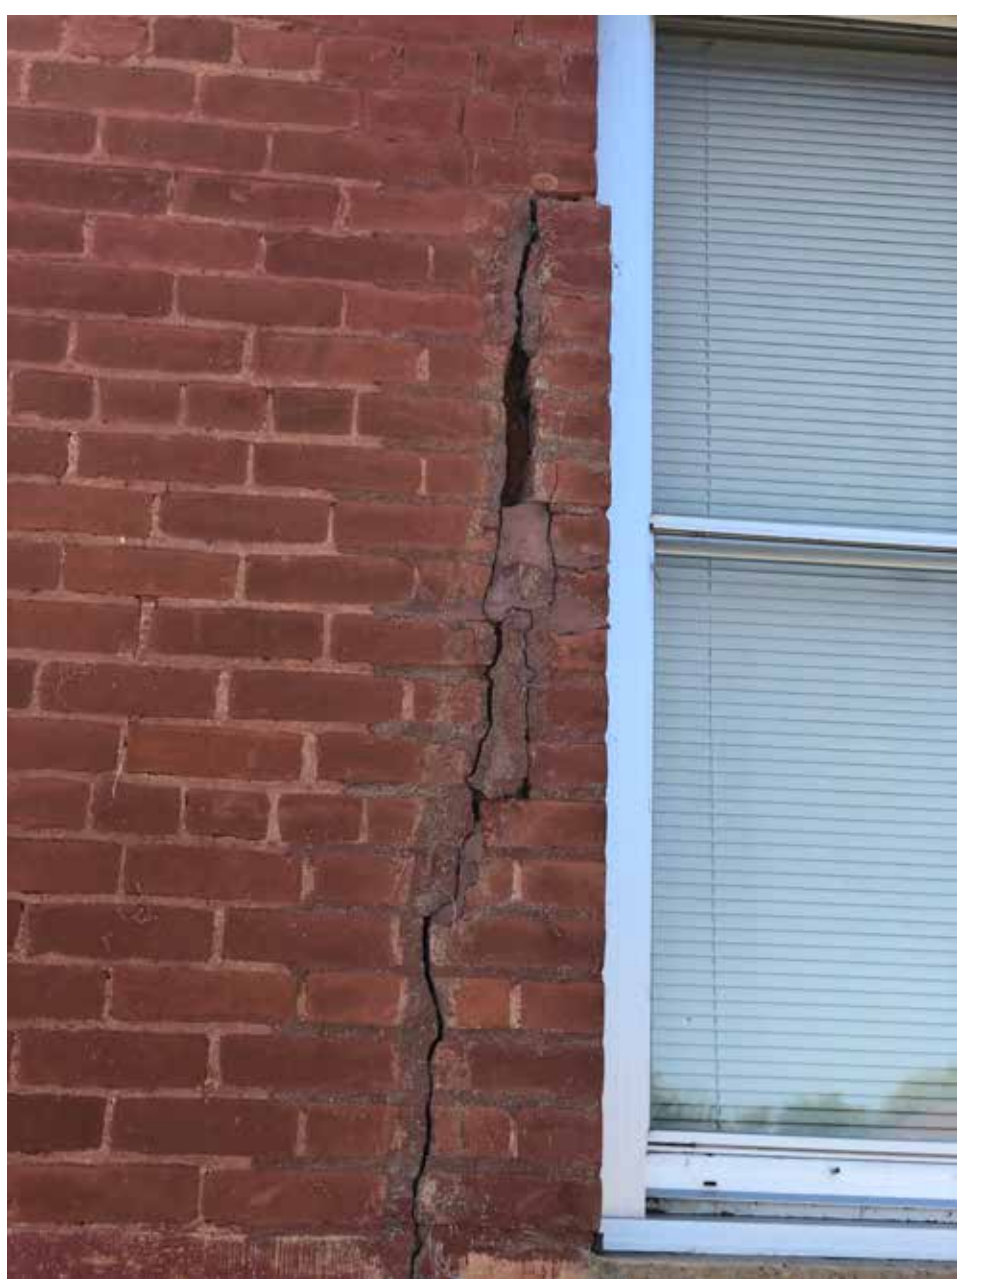
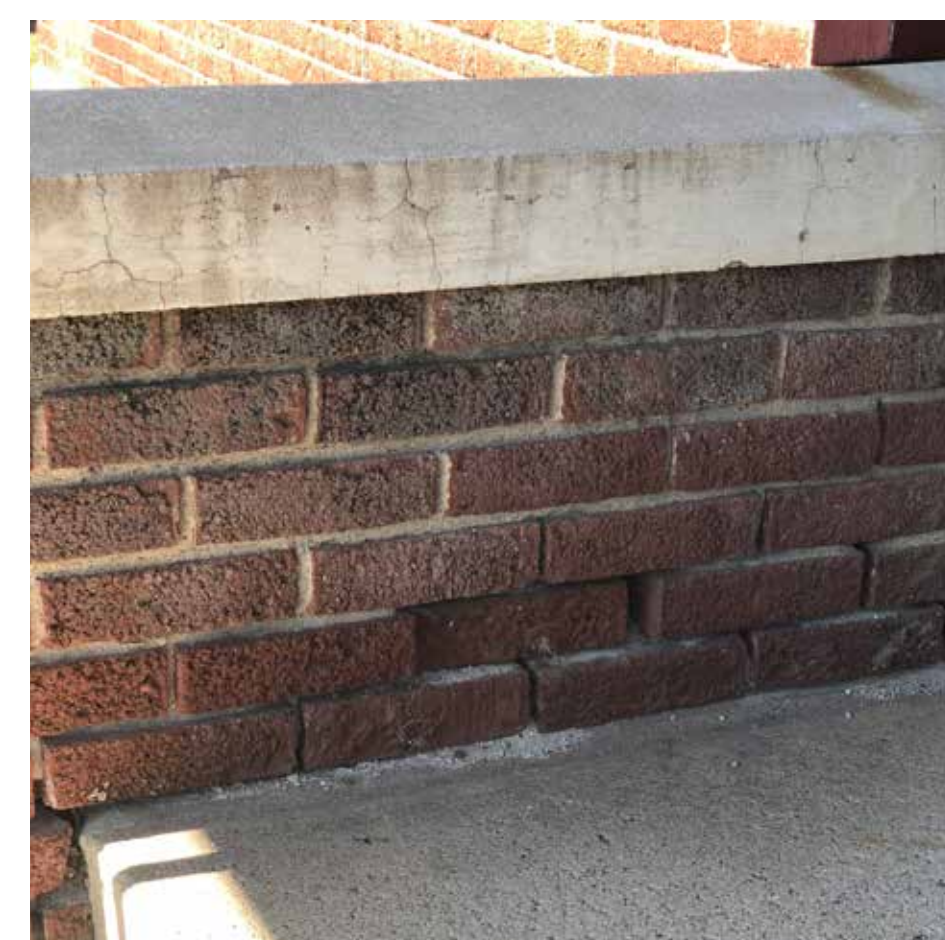
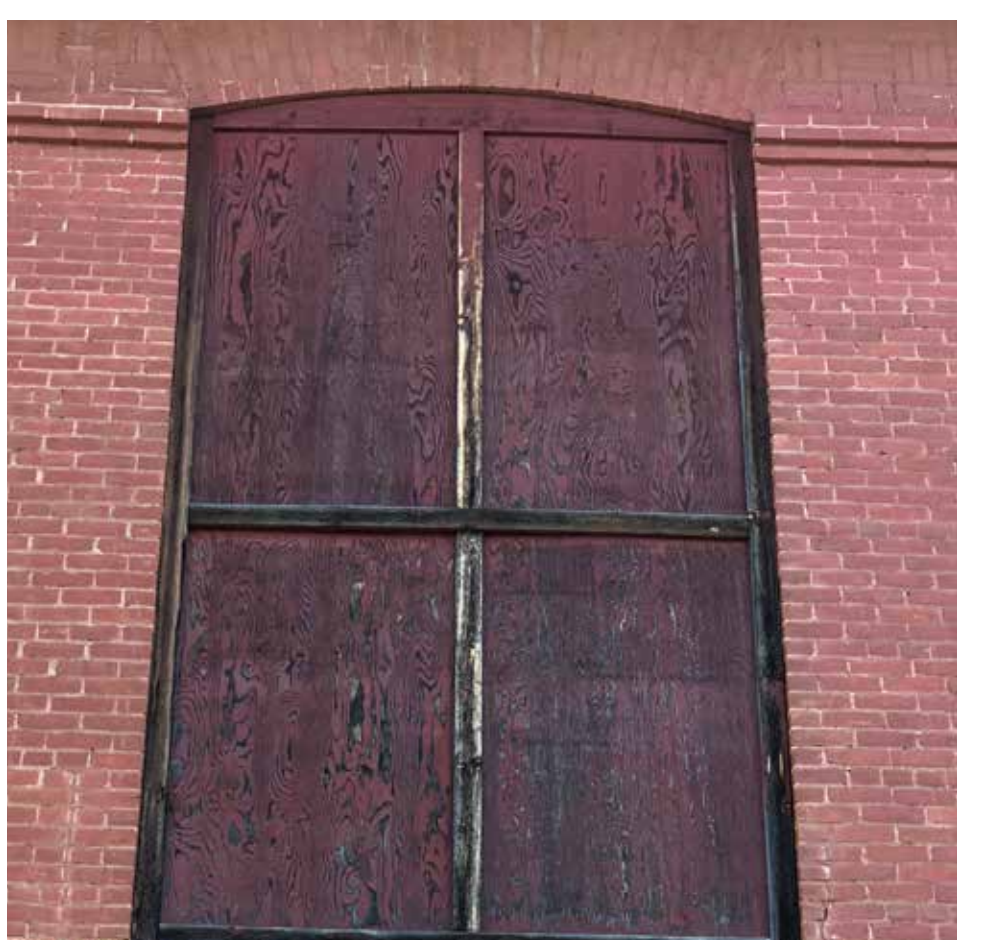
- A. Stone foundation built without a footing causing settling with cracks. This has been a problem since construction 127 years ago.
- B. Mortar between stones has turned to sand or missing, creating voids between stones. Foundation no longer serves as continuous rigid beam.

- C. North end of building tied together with steel rod extending through building and secured at each end on outside with plates and nuts.
- D. Joints on north wall severely eroded causing severe water infiltration. Brick has fallen out of header above windows.

- E. Several windows have been removed and filled with studs and solid painted plywood giving the building a boarded-up look.
- F. Original rafters are undersized for span causing roof to sag. Rafter tails rotated upwards pulling wood soffit and decorative elements away from brick.

- G. Bottom of stone foundation is 3' below grade and is susceptible to frost action.
- H. Second floor window headers have cracks or loose brick and evidence of weakened structural integrity.
