### TRAVERSE COUNTY COURTHOUSE

#### PRESENTATION & DISCUSSION

Traverse County
September 19, 2018

Richard P. Engan, AIA, LEED AP, CID Engan Associates Willmar, MN www.engan.com

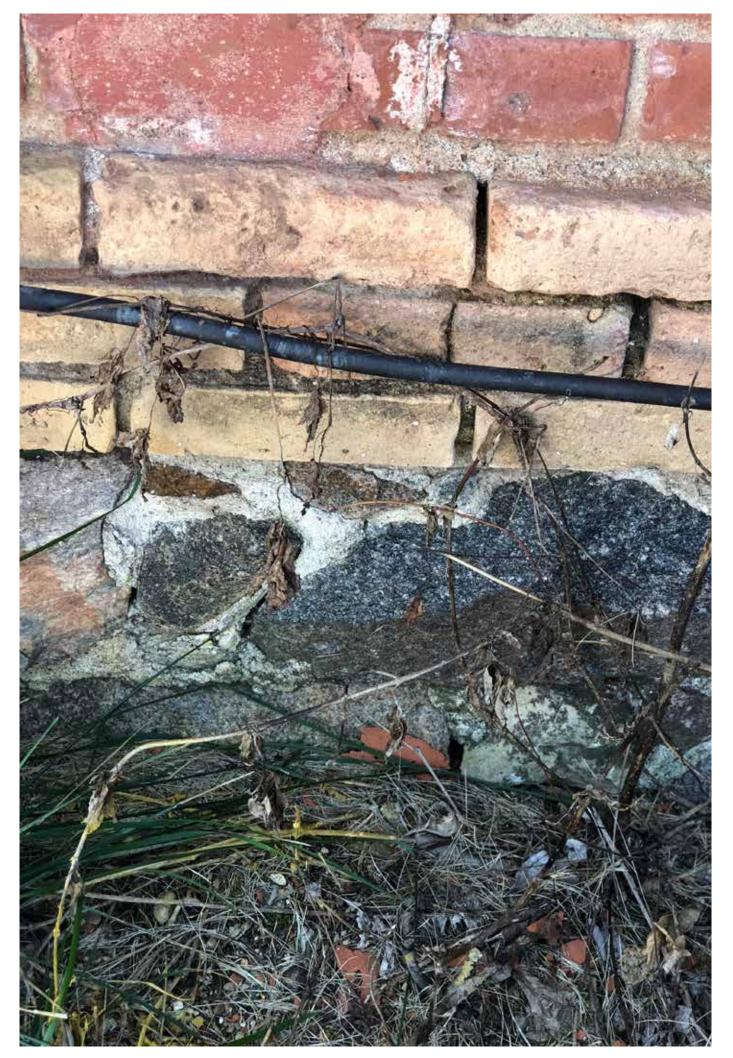
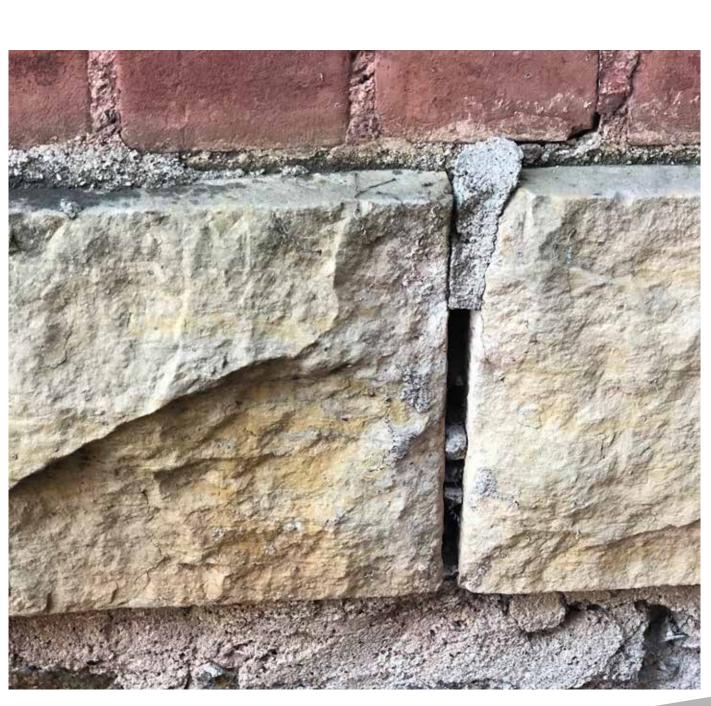
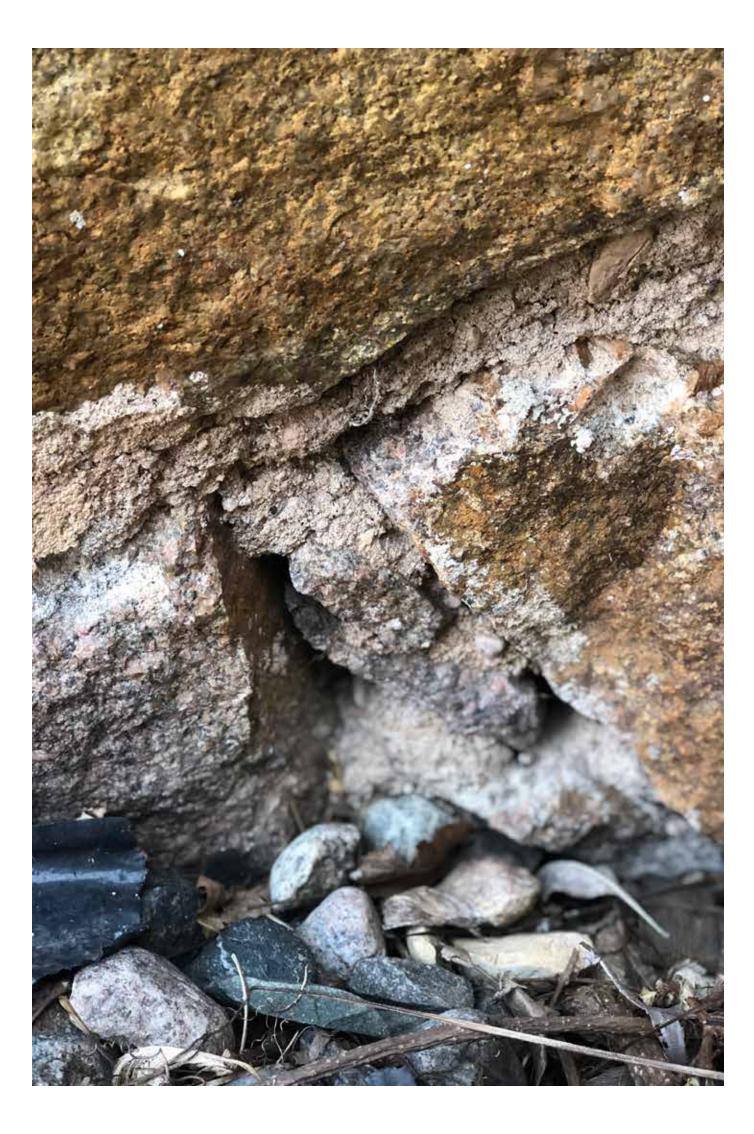
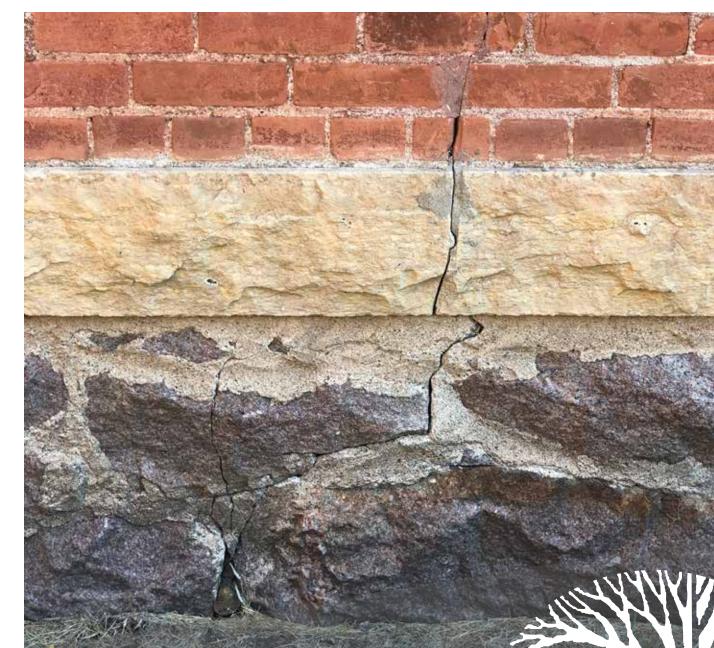
- A. Stone foundation built without a footing causing settling with cracks. This has been a problem since construction 127 years ago.
- B. Bottom of stone foundation is 3' below grade and is susceptible to frost action.
- C. Mortar between stones has turned to sand or missing, creating voids between stones. Foundation no longer serves as continuous rigid beam and is susceptible to movement.
- D. North end of building tied together with steel rod extending through building and secured at each end on outside with plates and nuts.

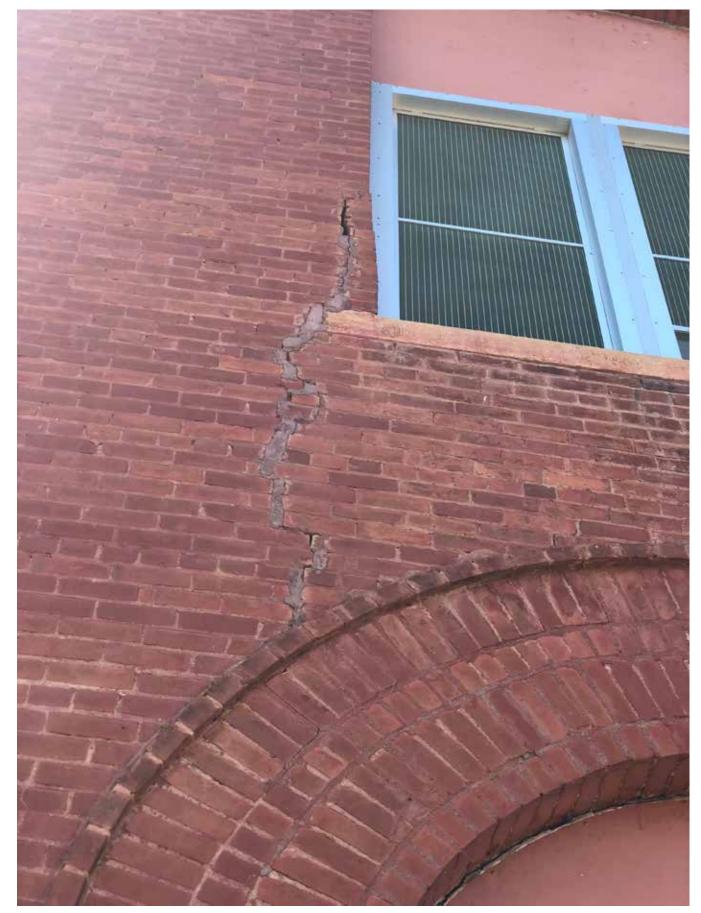
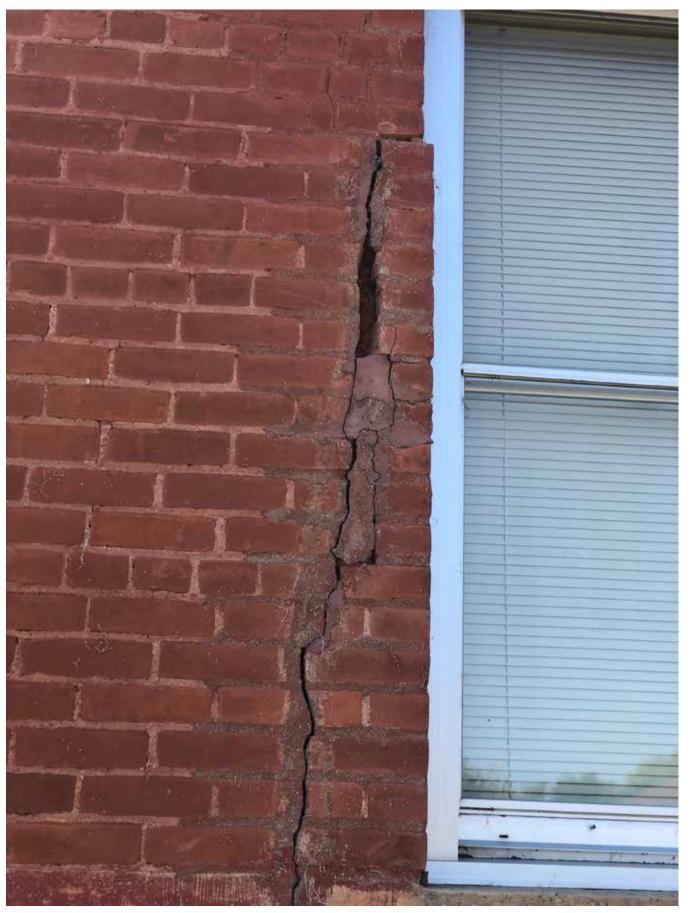
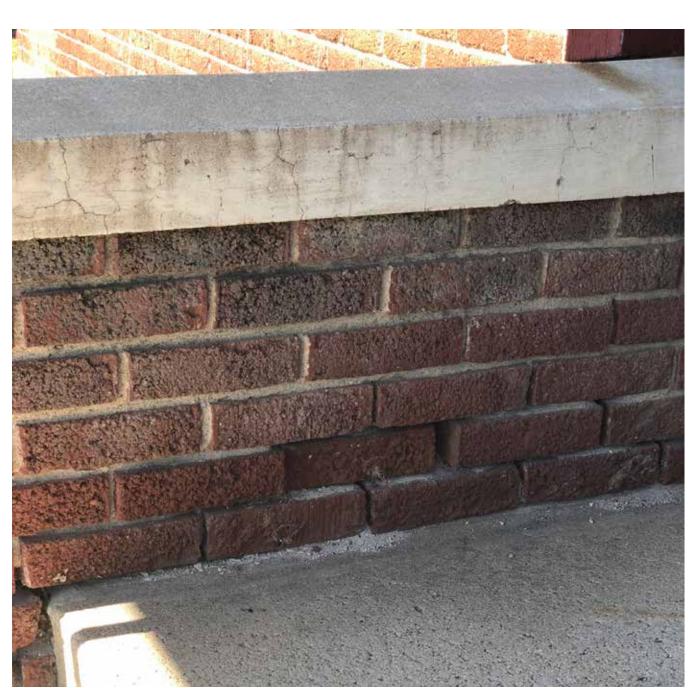
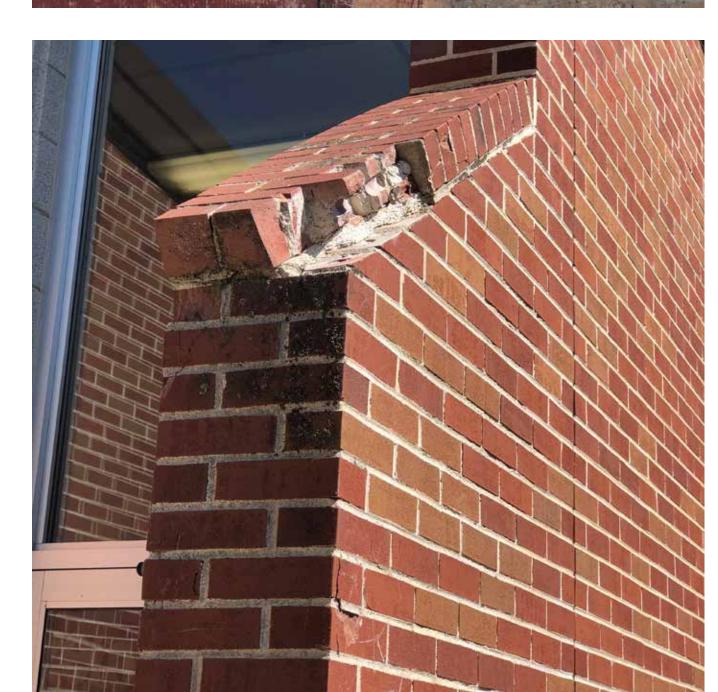
- E. Water runoff from 1973 addition is eroding the mortar joints and deteriorating brick of 1891 building.
- F. Joints on north wall severely eroded causing severe water infiltration. Brick has fallen out of header above window.
- G. Crack in east wall has accelerated movement and damage to brick.
- H. Second floor window headers have cracks or loose brick and evidence of weakened structural integrity.

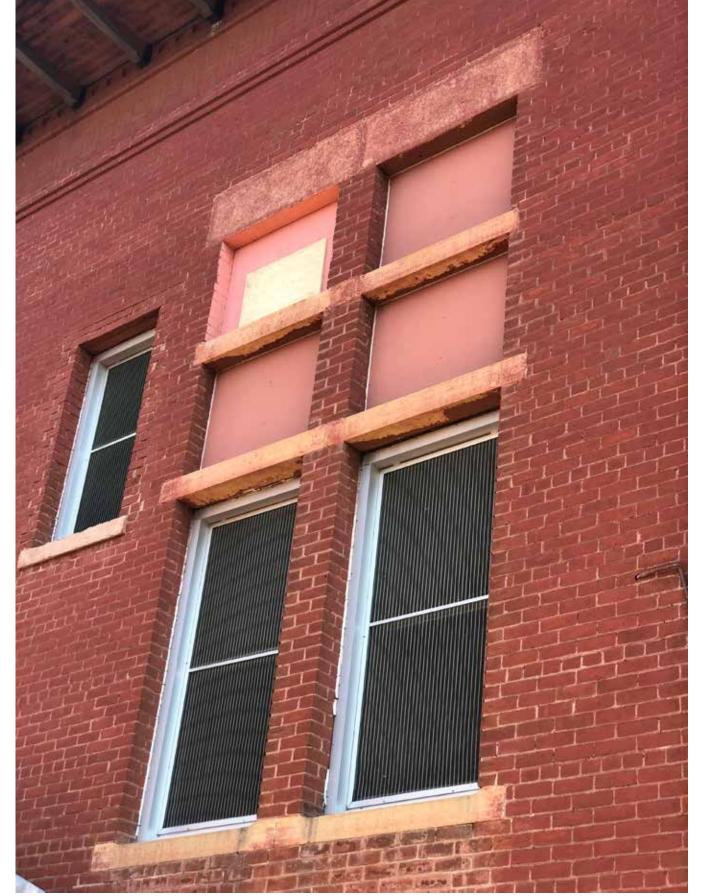
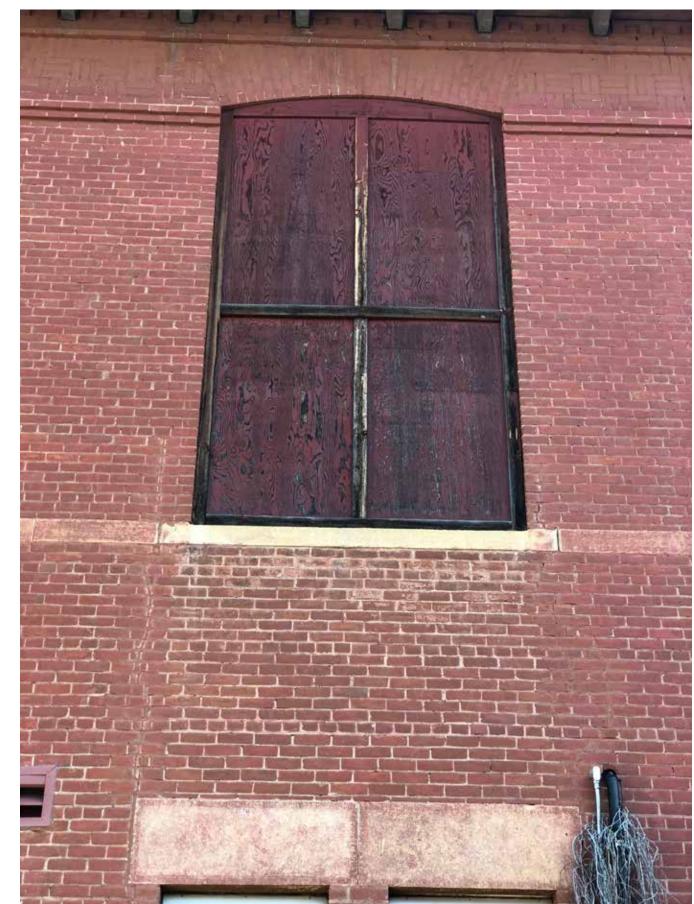
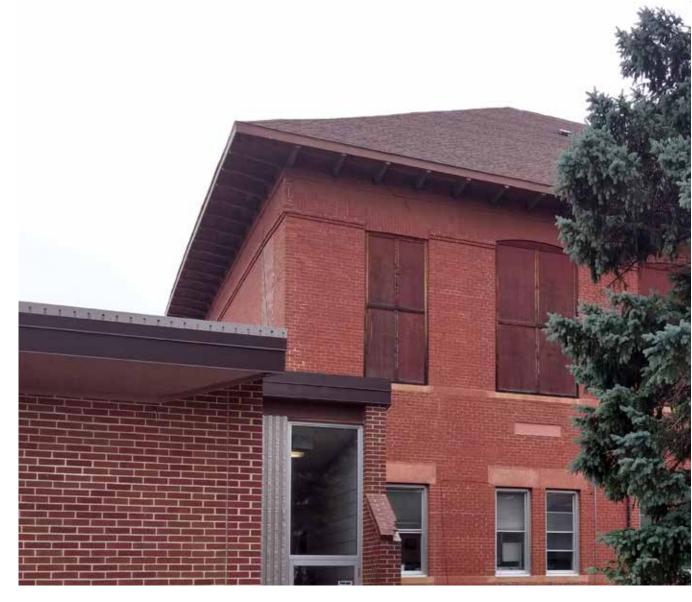
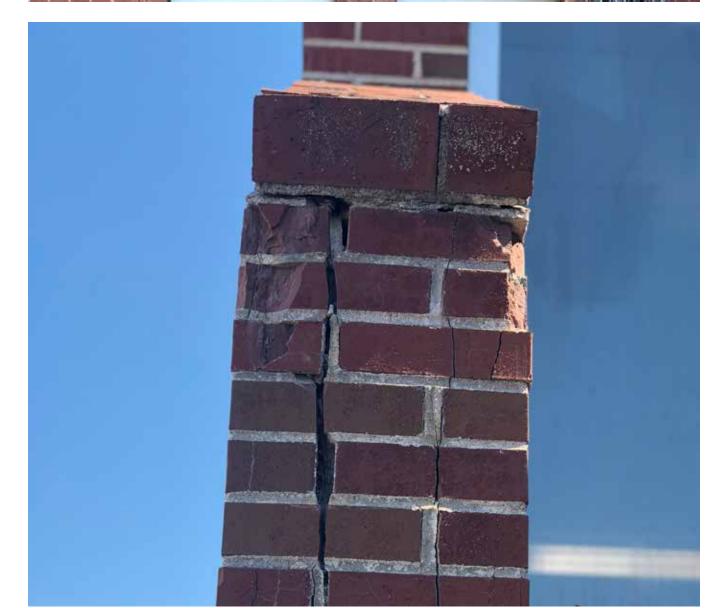
- I. Several windows have been removed and filled with studs and solid painted plywood. This gives the building a boarded-up look.
- J. Weather stripping is aged and allows dirt and air leakage to occur.
- K. Original rafters are undersized for span causing roof to sag. Rafter tails rotated upwards pulling wood soffit and decorative elements away from brick.
- L. Wood boards on underside of eaves are rotting out. Metal trim under soffits is rusted.

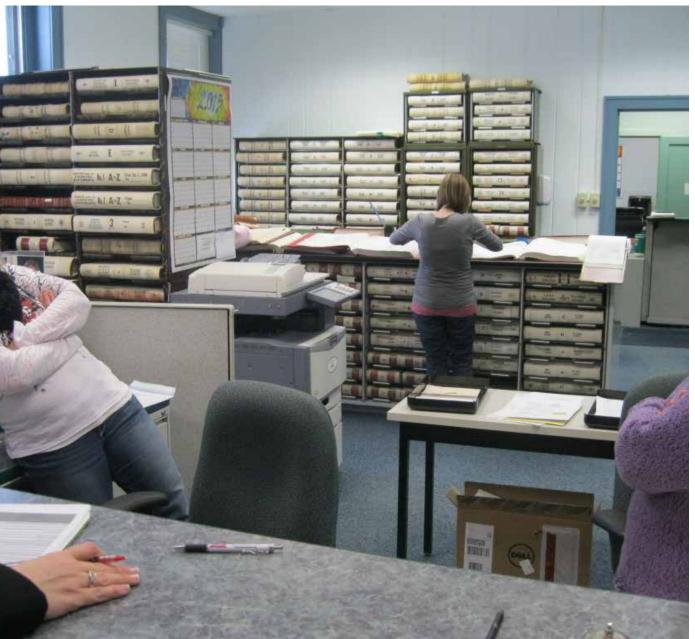
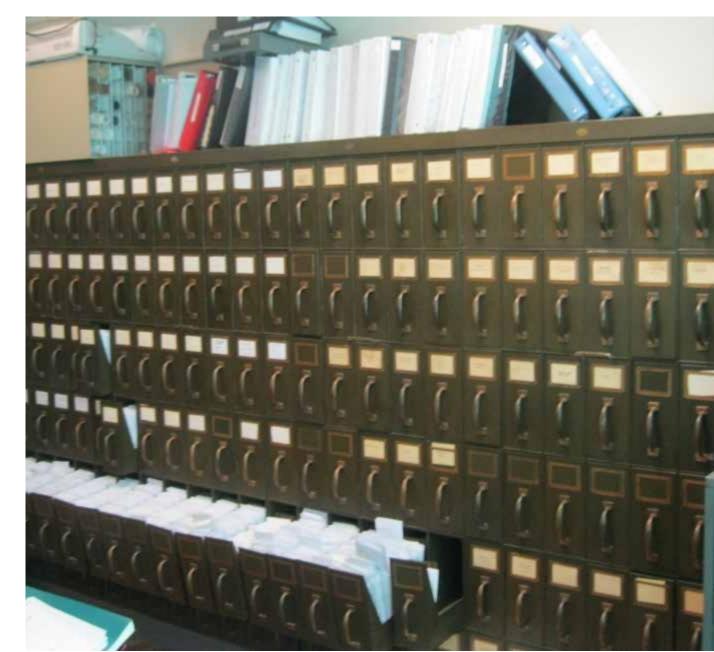
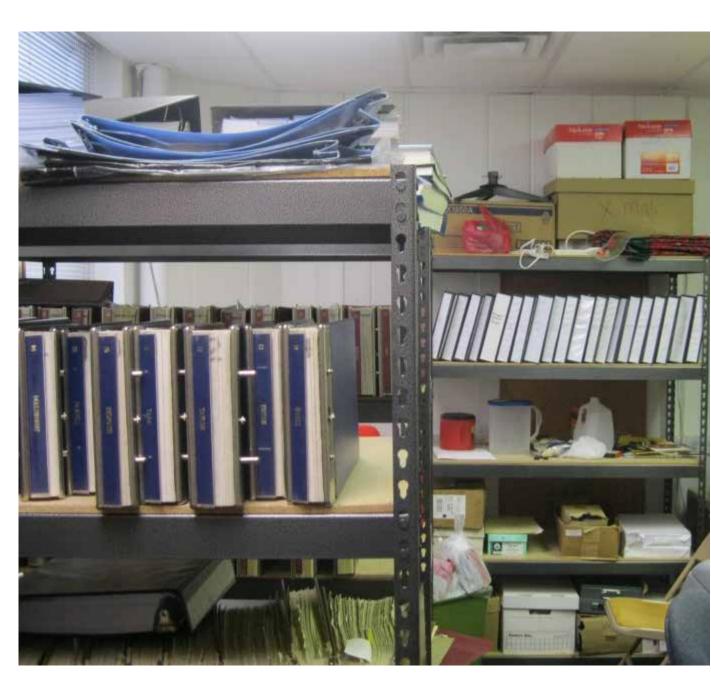
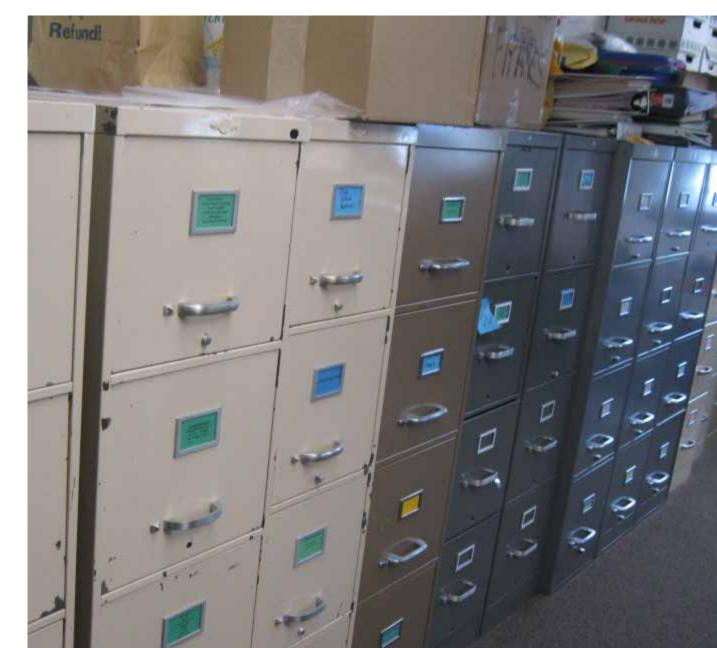
- A. The building is hard to use efficiently. The heavy vault and building walls do not allow modification of space to use efficiently.
- B. Shortage of adequate work and storage space for the departments housed in the building.
- C. The configuration of the building and construction type places limits on how a remodeling/expansion program could be accomplished.

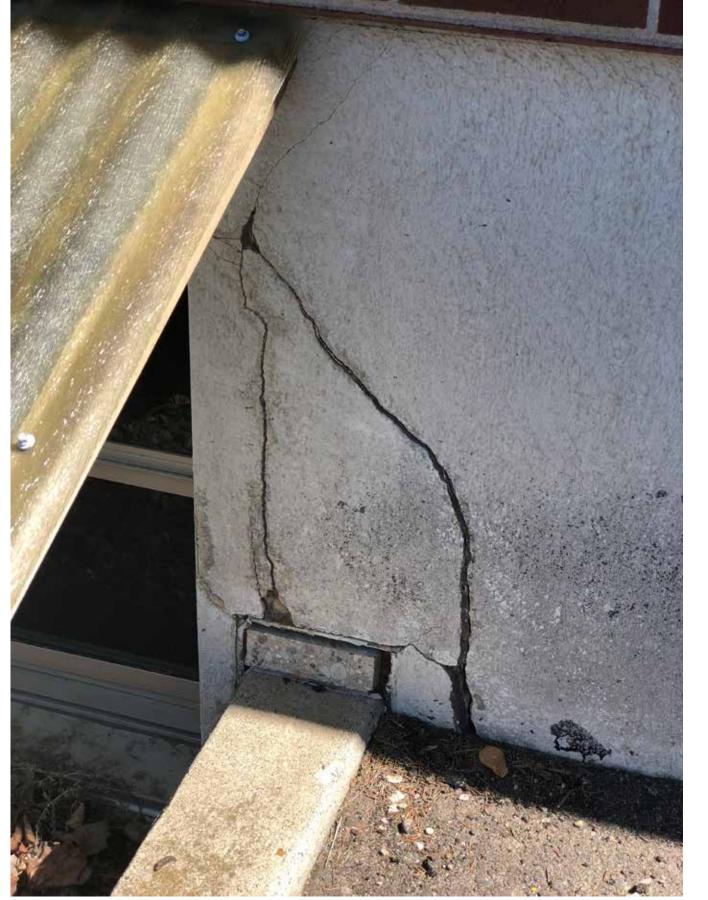
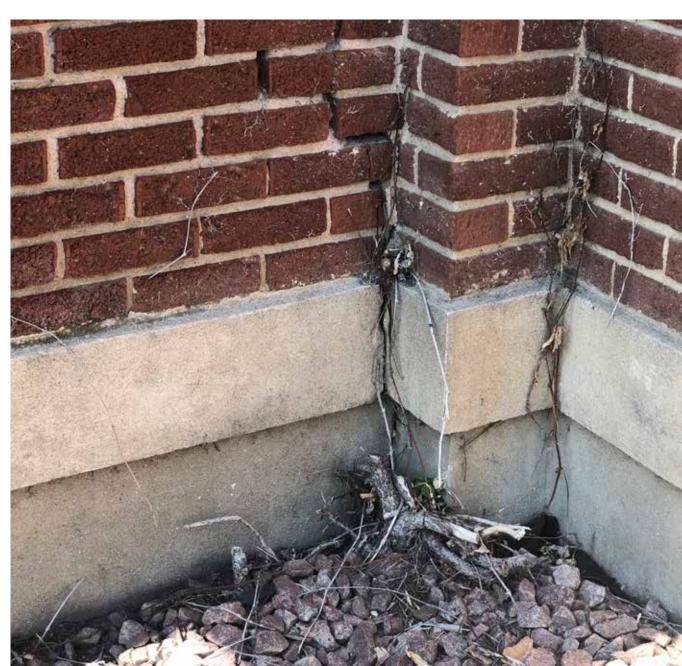
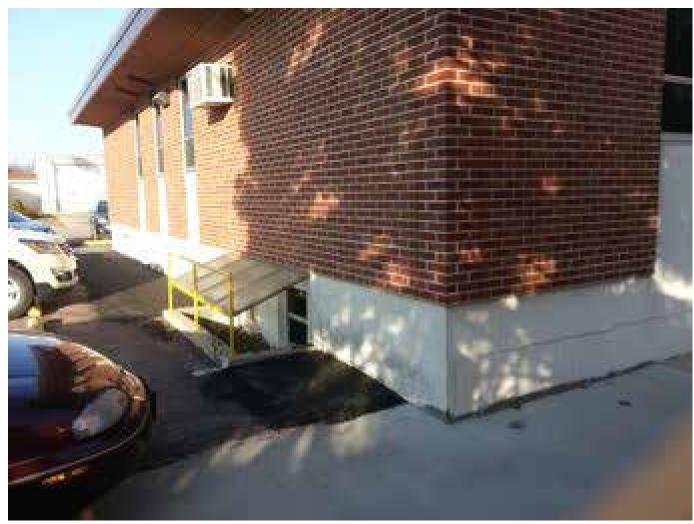
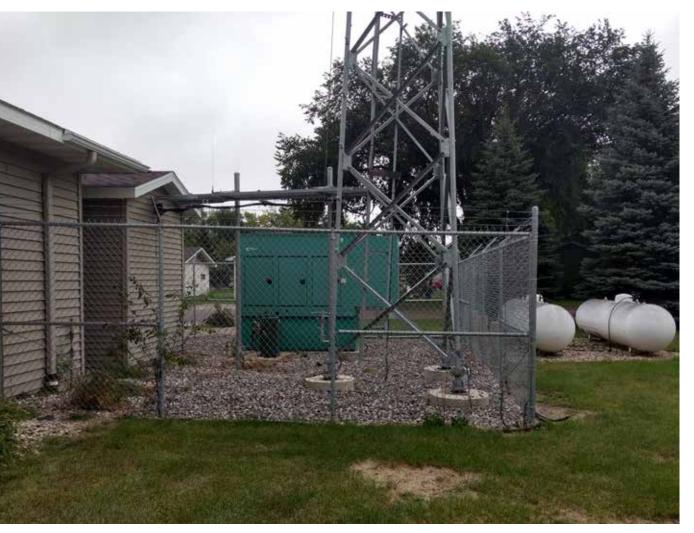
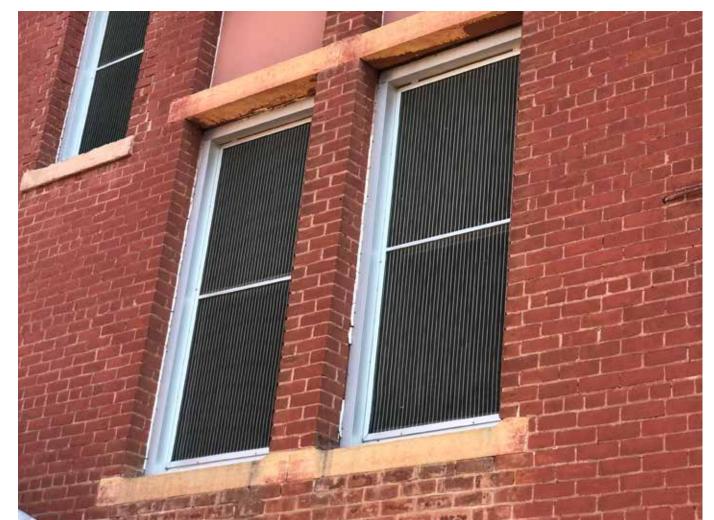
- A. Wall are uninsulated and windows are single glazed panes making it costly operate.
- B. The basement at the north has leaked since building was constructed developing mold. Due to this, the basement has not been used and the building causes breathing issues.

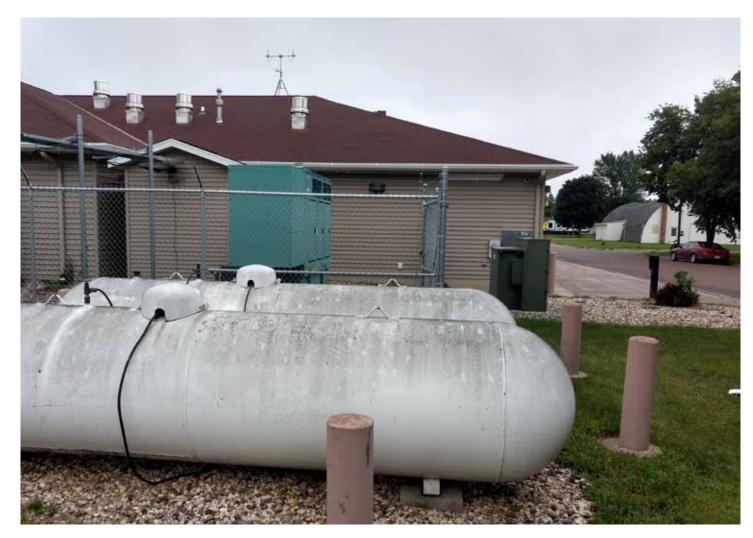
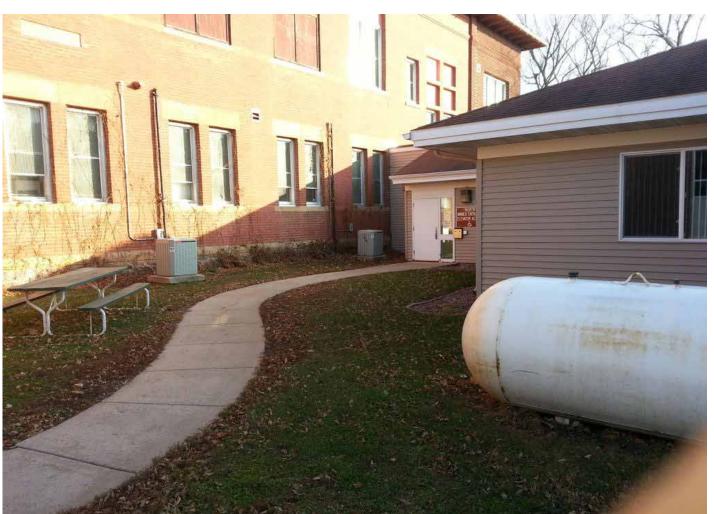
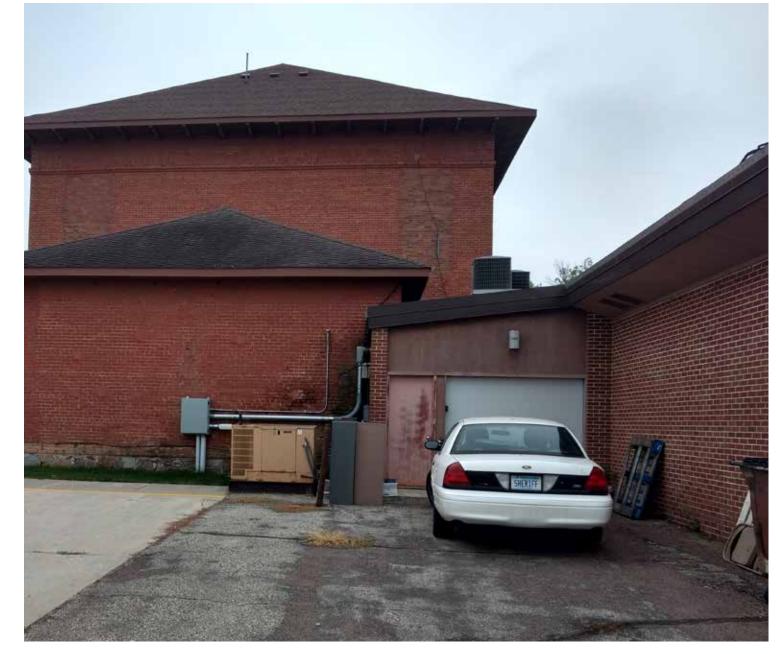
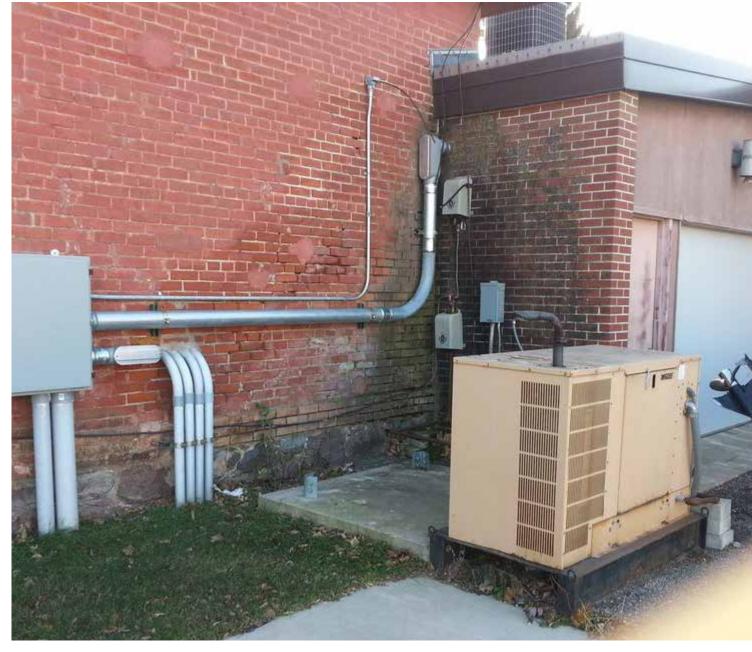
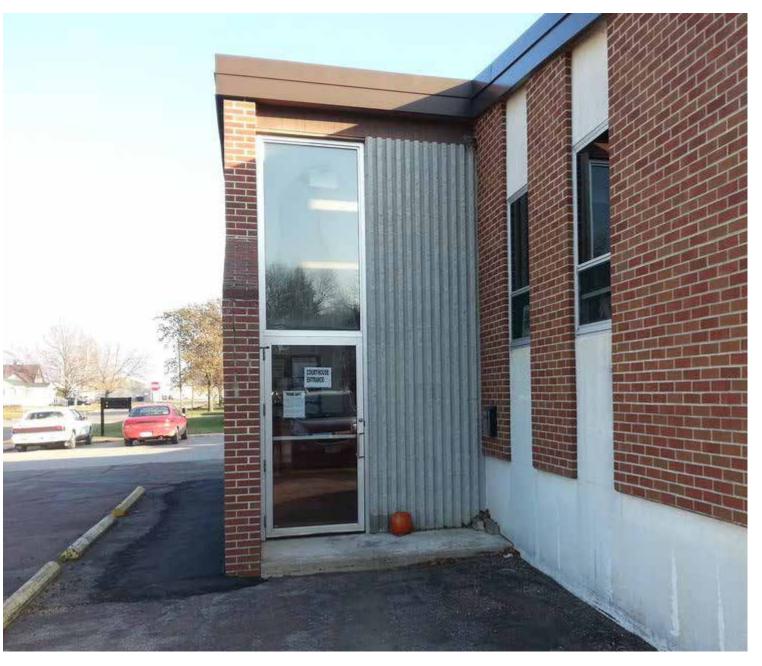
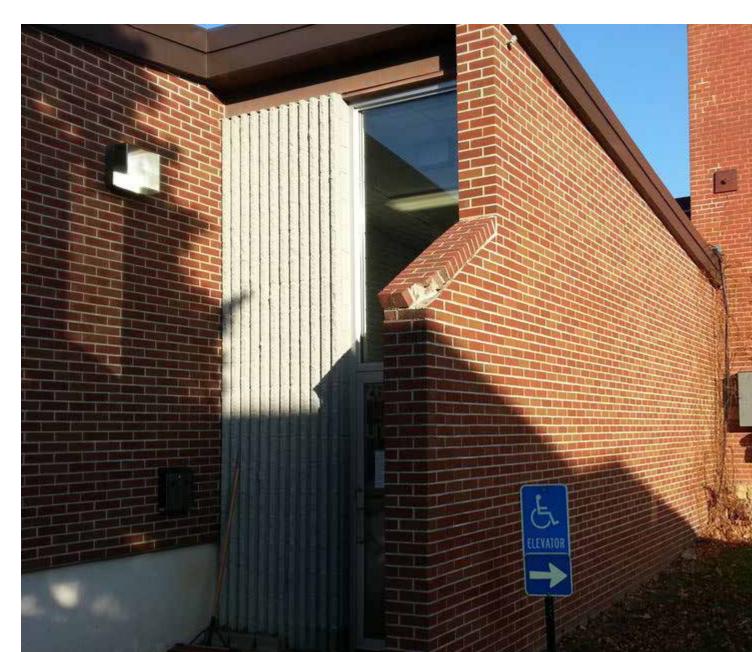
- A. The public can enter by multiple unobserved entrances.
- B. How can the Courthouse provide a welcome face to the public while improving the security of the building.
