Traverse County Courthouse

BUILDING EVALUATION - SPACE NEEDS STUDY 16 JULY 2012

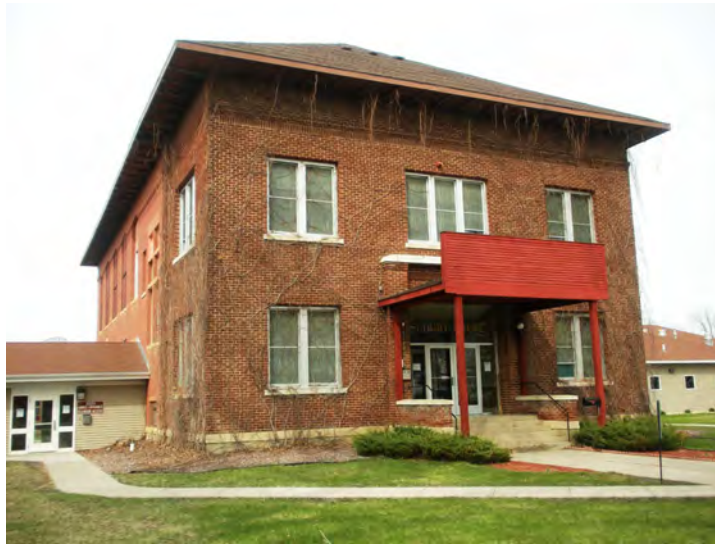
View of the south façade, wood portico and annex entry

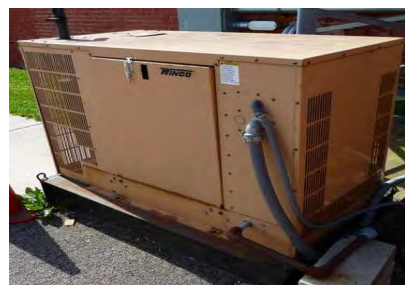
An external, 20 kw, 120/240 volt, single phase, propane based emergency generator is located at the back of the Courthouse Building. It is dedicated specifically for backup of the abandoned 1974 dispatch area, the Courthouse Building telephone service and County servers. This Winco generator and automatic transfer switch have reached the end of their useful life.

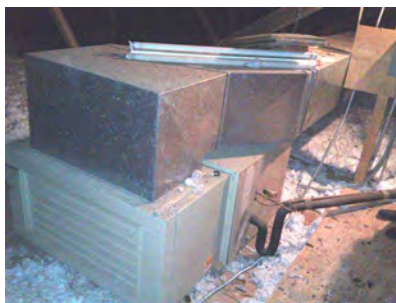
Generally these units are in good condition with the exception of the expansion area basement furnace, which shows rust due to basement flooding. All these units have operated more than half of their life expectancy and consideration should be given for eventual replacement. The second floor court area is heated and air conditioned by means of an attic mounted fan-coil unit with a 20KW electric duct heating coil and a 7 ½ ton DX cooling coil/condensing unit. This unit is also a similar
